**Federal Clean Water  
Section 319 Grant**  
2002-0060

## **Sebewaing River Watershed Tillage & Cover Crop I&E Project**

September 15, 2002 through June 30, 2005

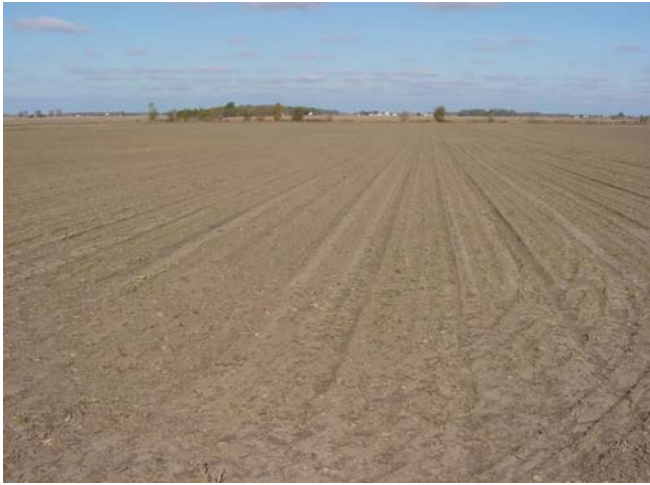
**McNeil Tillage Demonstration Site Before:**

A typical sugar beet field after harvest in the Sebewaing River Watershed is left with no residue to protect the soil from wind and water erosion over the winter months. This site has drains on three sides.

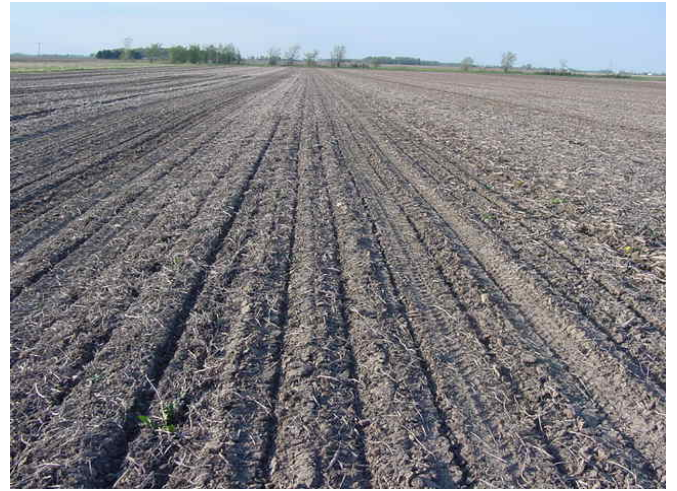
**McNeil Tillage Demonstration Site After:**

Randomized and Replicated Strips have been established on this site to compare conventional and zone tillage. The photo shows corn stalk residue left over winter to provide protection. The zone-built strips have been installed and in the spring planting will be done directly over these slots without additional tillage.

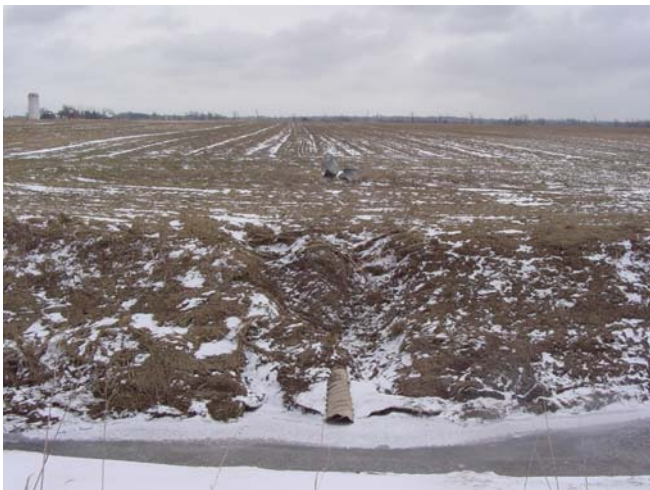
A typical fall plowed field in the watershed. This field is prone to wind and water erosion. The proximity to the drain leads to sediment and nutrient loading.

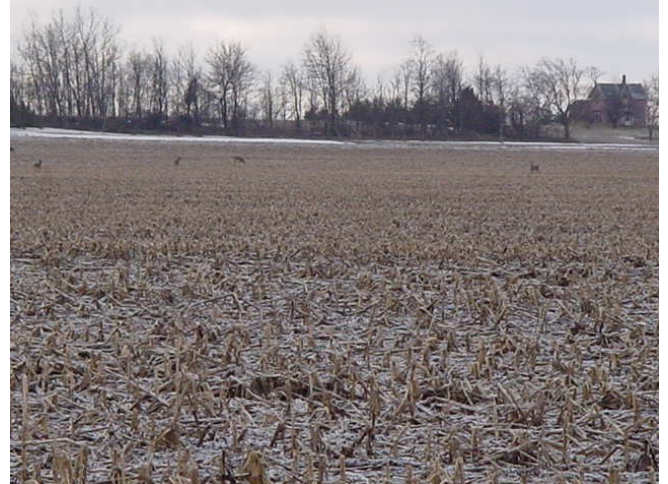
Corn stalk residue left in place over winter reduces wind and water erosion and sediment and nutrient deposition. Corn stalks also provide wildlife cover and a winter food source.
